Manhole Inspection Summary

Manhole # S31S1_011MH

Insp Date: **2/15/08 10:32 AM**

Location Address: **1355 Spelman Road**

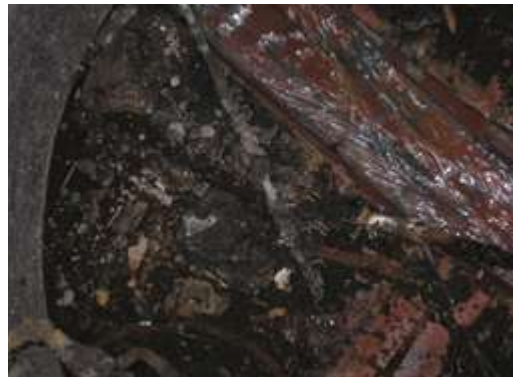
Defect 1

Bench

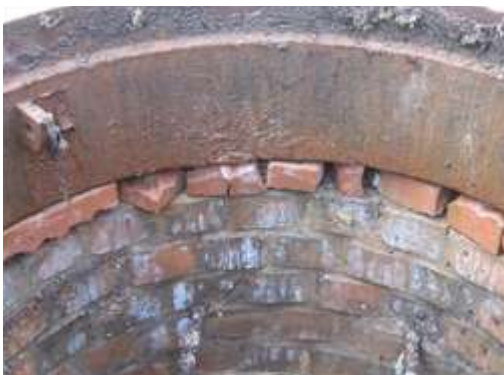
Defect 2

Condition: ☐ Sound ☐ Cracked ☐ Root Intrusion ☒ **Loose Brick** ☐ Deteriorated

Infiltration: ☐ None ☒ **Joint** ☒ **Cracks** ☐ Mortar ☐ Roots ☐ Wall

Chimney

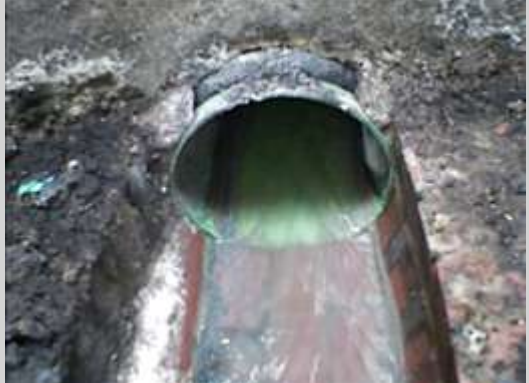
12 O'Clock Outflow

8 in. Circular Gravity Sewer
Pipe Out @ 12 O'Clock

Pipe Height: **9.6** (in.) Rod and Bar (Angled)
Pipe Material: **PVC** ☐ Pipe Lined
Invert Depth: **8.84** (ft.) Flow Characteristics: **Fast**
Deposits: ☒ None ☐ Mud ☐ Sludge ☐ Debris ☐ Grease
Silt Depth: (in.) Deposits Extent:
Infiltration: **None** Pipe Seal Cond: **Sound**

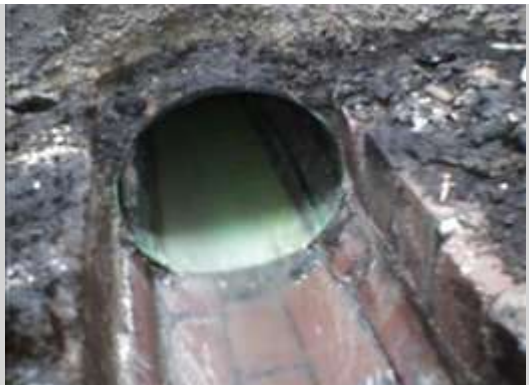
6 O'Clock Inflow

8 in. Circular Gravity Sewer
Pipe In @ 6 O'Clock

Pipe Height: **8.4** (in.) Rod and Bar (Angled)
Pipe Material: **PVC** ☐ Pipe Lined
Invert Depth: **8.75** (ft.) Flow Characteristics: **Fast**
Deposits: ☒ None ☐ Mud ☐ Sludge ☐ Debris ☐ Grease
Silt Depth: (in.) Deposits Extent:
Infiltration: **None** Pipe Seal Cond: **Sound**
